WASH ASSESSMENT PHASE II: APPRAISAL AND BASELINE STUDY FOR BUNDA AND CHATO WASH SITES IN THE UNITED REPUBLIC OF TANZANIA

SEPTEMBER 10, 2014

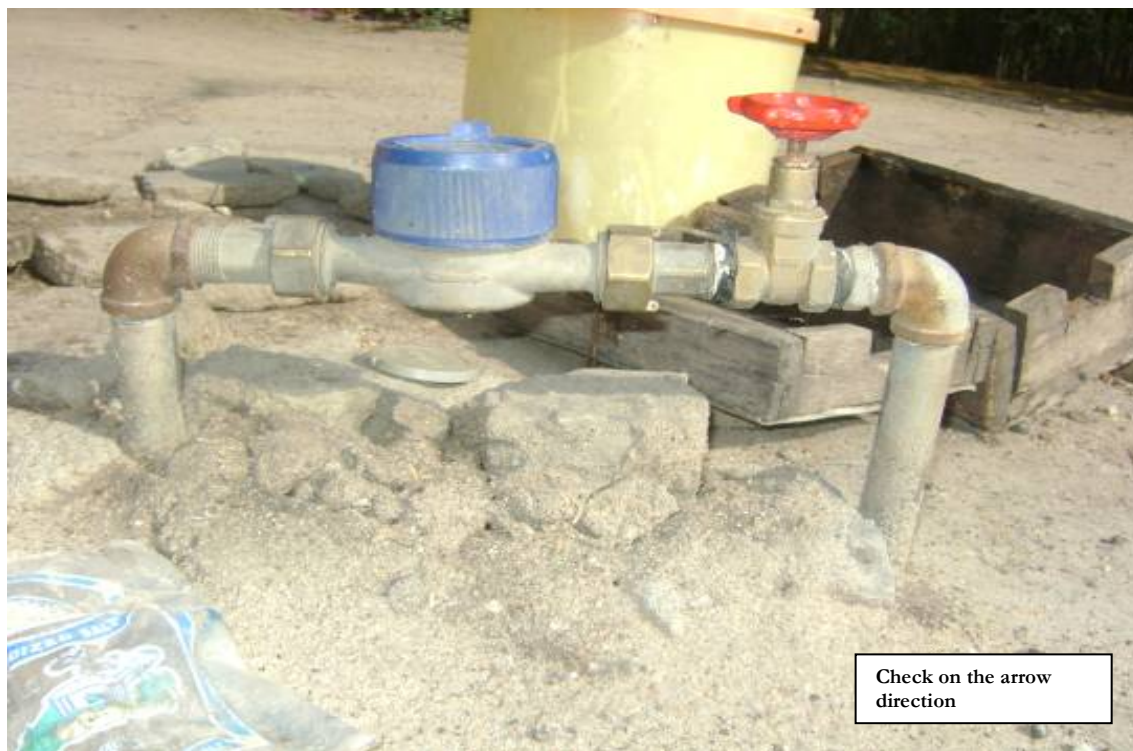
Metering enables the utility to charge consumers for the water they used appropriately. This is because water payment is then proportional to consumption. As a result, consumers will probably tend to consume less water in order to avoid excess water costs (consumer-pays principle). Metering is also a tool for controlling NRW resulting from commercial losses. Currently, the metering ratio in BUWSA is at 80%, leaving 20% of customers unmetered. This implies that BUWSA issues unmetered bills to those customers, a flat rate based on estimated consumption. The estimated bills could be part of the commercial losses or of overcharges on the customers' side. The major challenges facing metering efficiency in Bunda is the heavy workload for meter readers, attributed to inadequate staff. It is estimated that one meter reader is required to read at least 100 meters per day in a billing cycle of 30 days. Distribution of customers over a large area means meter readers must take even more time to do their job, thus affecting their efficiency. Another challenge is meter tampering by customers. It was reported that at least five incidences of meter tampering are reported every month. Figures 3, 4, and 5 show the different types of meter tampering in BUWSA, which plays a massive contribution to NRW.

Figure 3: This is an example of a “reversed” meter. It has been tampered with so it can register a low reading.

Based on the above empirical evidence, it is clear that meter tampering is a serious problem that needs to be addressed urgently. Section 47 of the Water Supply and Sanitation Act (2009) requires a person who destroys or damages a water or sewerage system to pay a fine of TZS 50,000 to TZS 5 million or to be imprisoned for one month to five years (or both). From this provision, BUWSA can develop relevant rules or other tools with respect to the local context in order to address this vandalism problem. Additionally, strengthening the established incentive packages for reporting illegal connections and for reporting on those damaging the network system would be essential. Awareness and community engagement regarding service provision issues is also important.

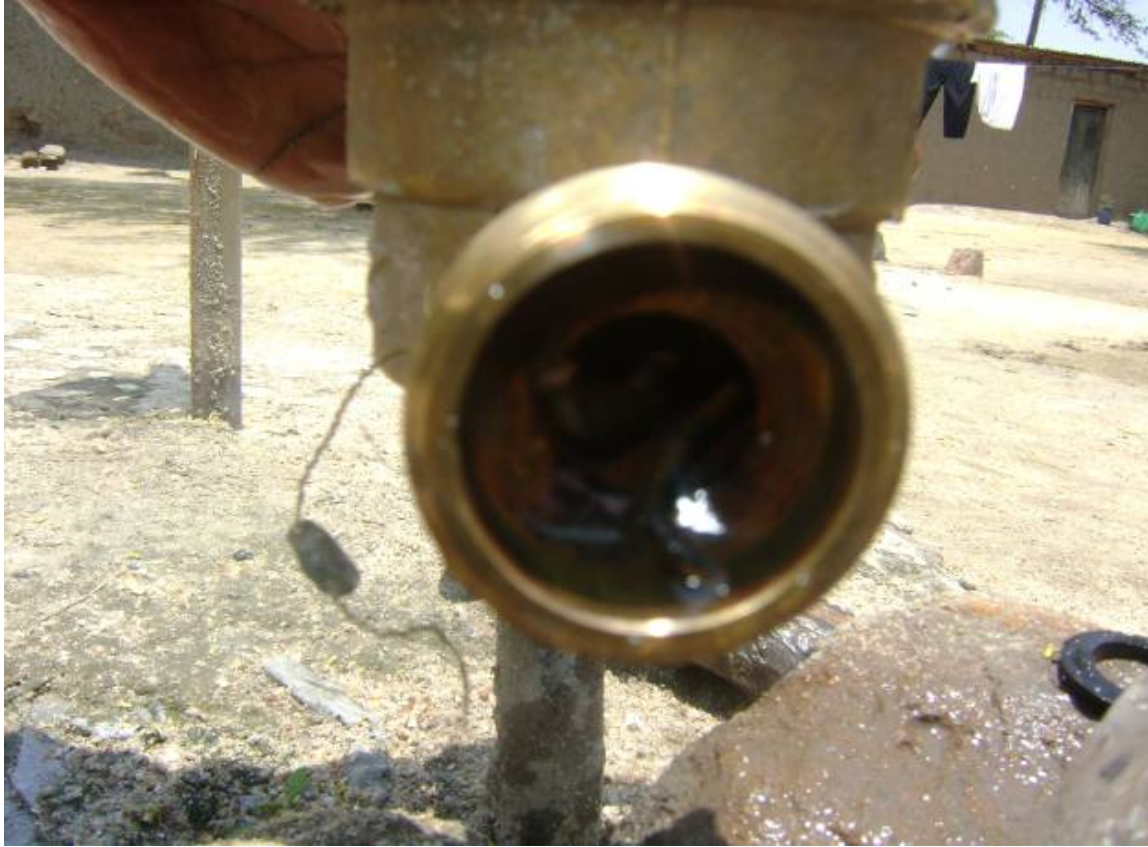
Figure 4: Meter with inserted steel wire to prevent it from measuring consumed water

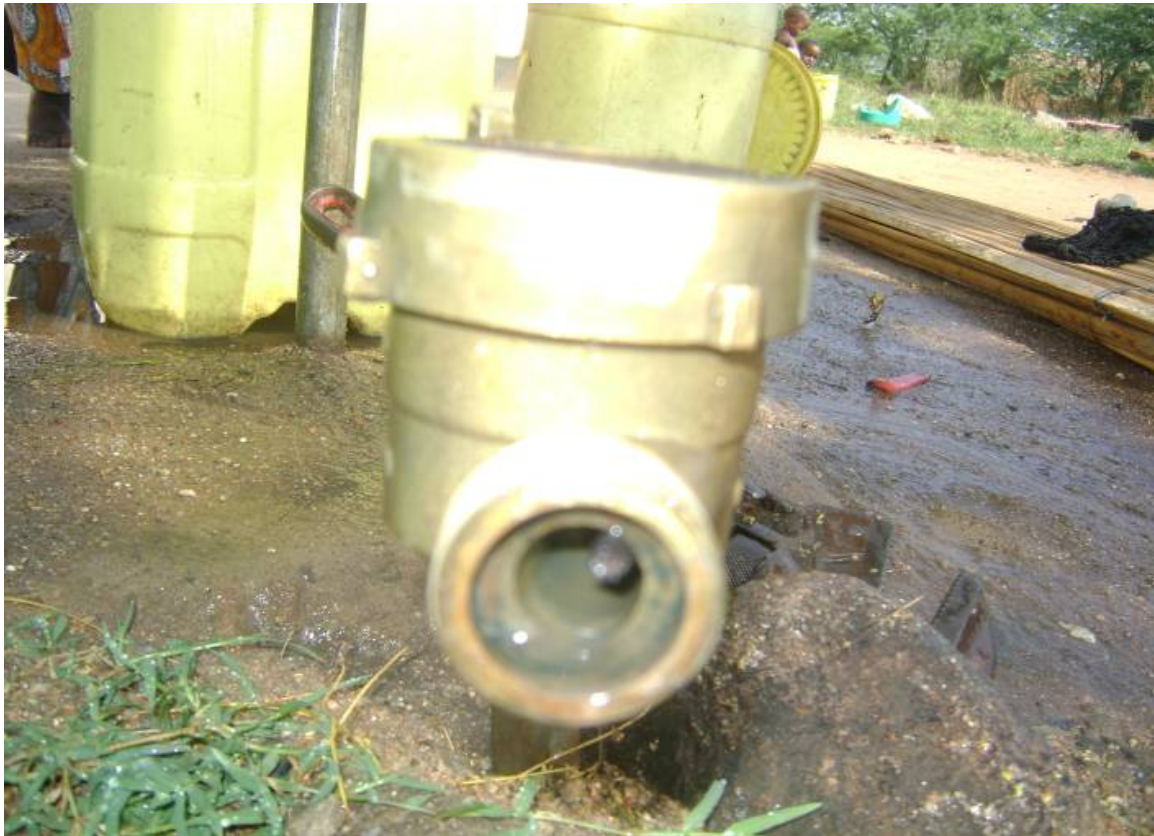
Figure 5: Part of a stick inserted in a water meter to prevent it from measuring consumed water

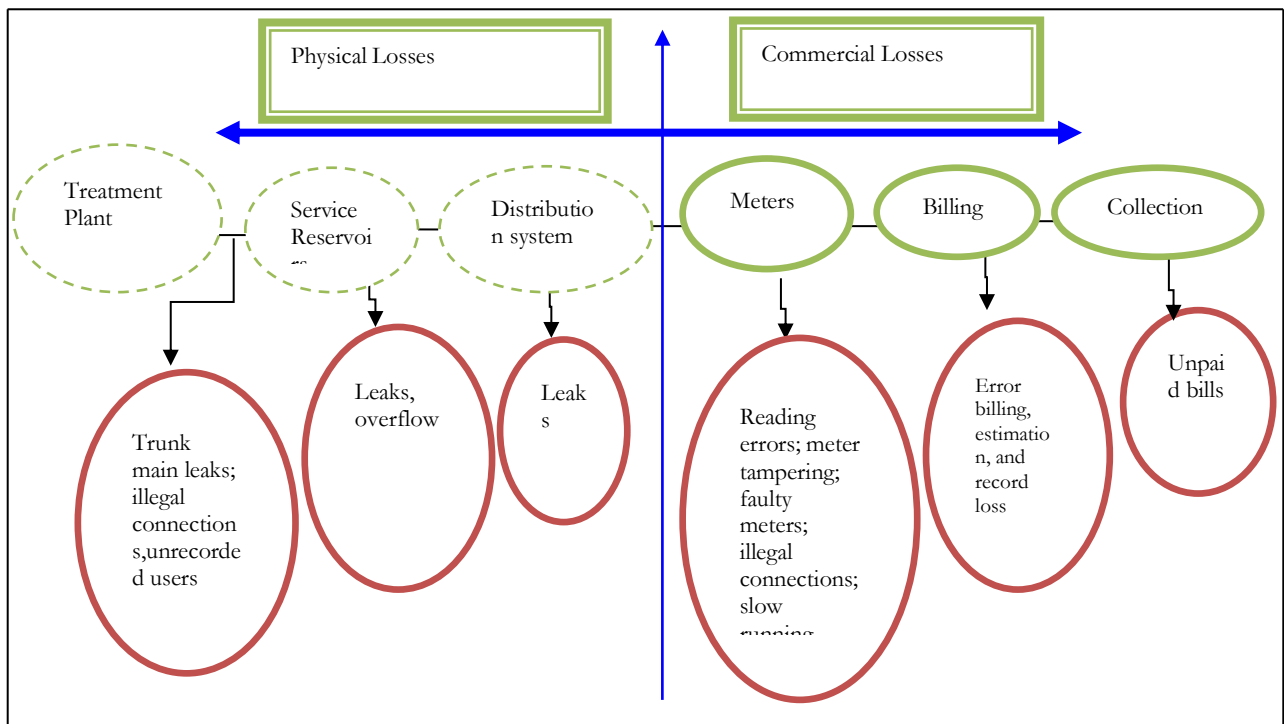
Reduction of NRW in BUWSA is one of the key proposed activities. Water losses were reported to be due to network leakages, burst pipes, vandalism, illegal connections, billing errors, erroneous meters, and other administrative errors. Therefore, a diagnostic study on the factors contributing to physical and commercial losses as shown in Figure 6 will be necessary. The results of the diagnostic study will determine the way forward in measuring reduced NRW. However installation of master/bulk meters (both for production and supply) and revenue meters are issues that should be strongly considered during implementation of the proposed PREPARED interventions.

Figure 6: Possible causes of physical and commercial water losses
